THE INSTITUTE OF PAPER SCIENCE AND TECHNOLOGY

Corrosion in Electrostatic Precipitators

Project 2926-9

R E P O R T T W O

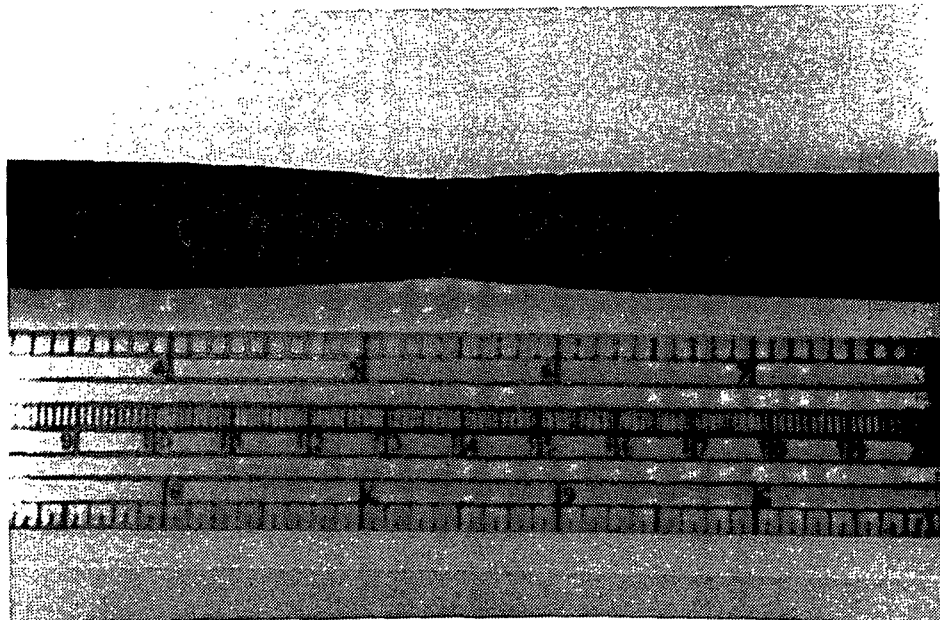
Figure 23. A view of the shaft of the west side retractable ER probe that suffered extensive corrosion.

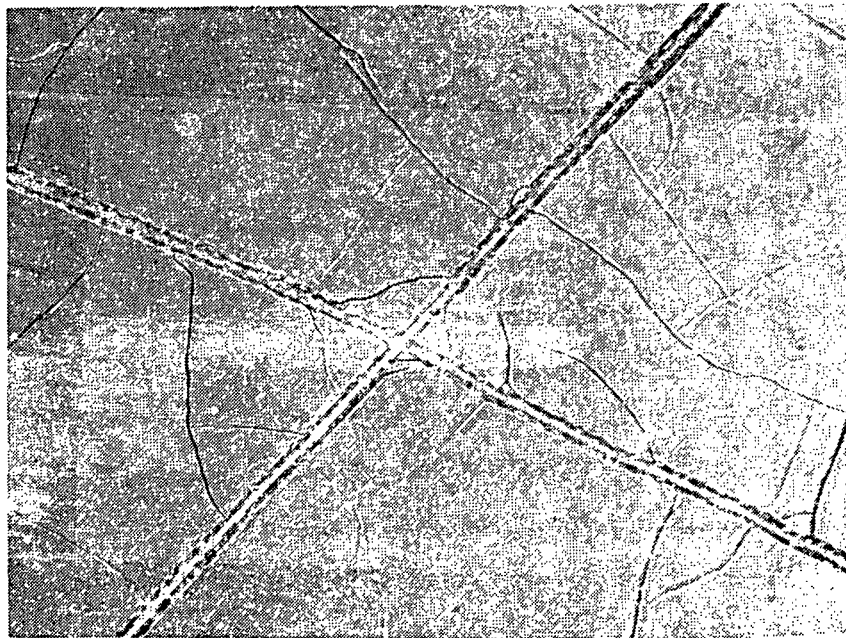
Figure 30. The S&G 350 coating was subject to cracking when exposed in the electrostatic precipitator. The large "X" is the intentional damage to the coating performed on a specimen of each coating type. (6X)

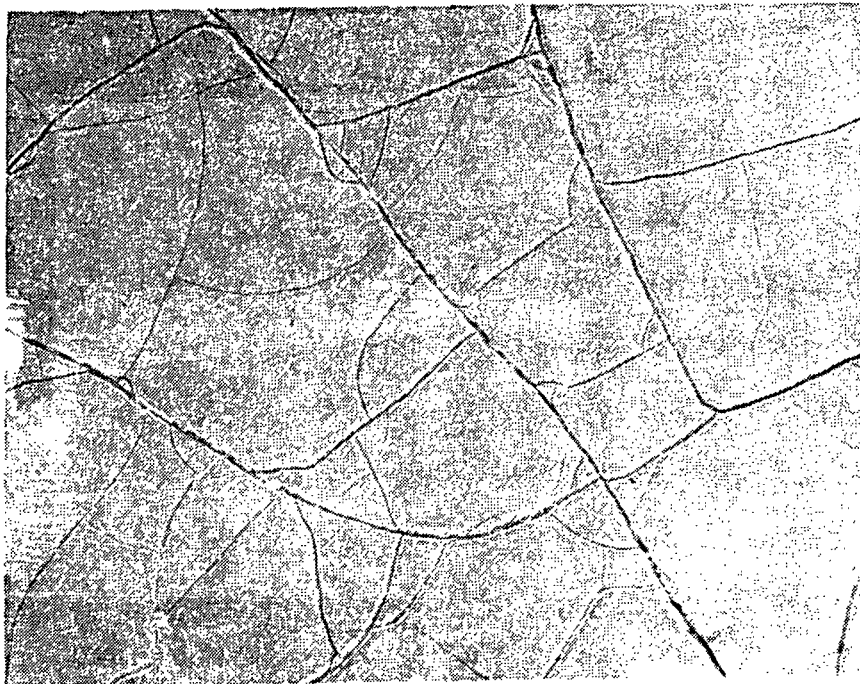
Figure 31. Cracking of the S&G 350 coating material also occurred in areas not in the vicinity of the simulated surface damage. (6X)

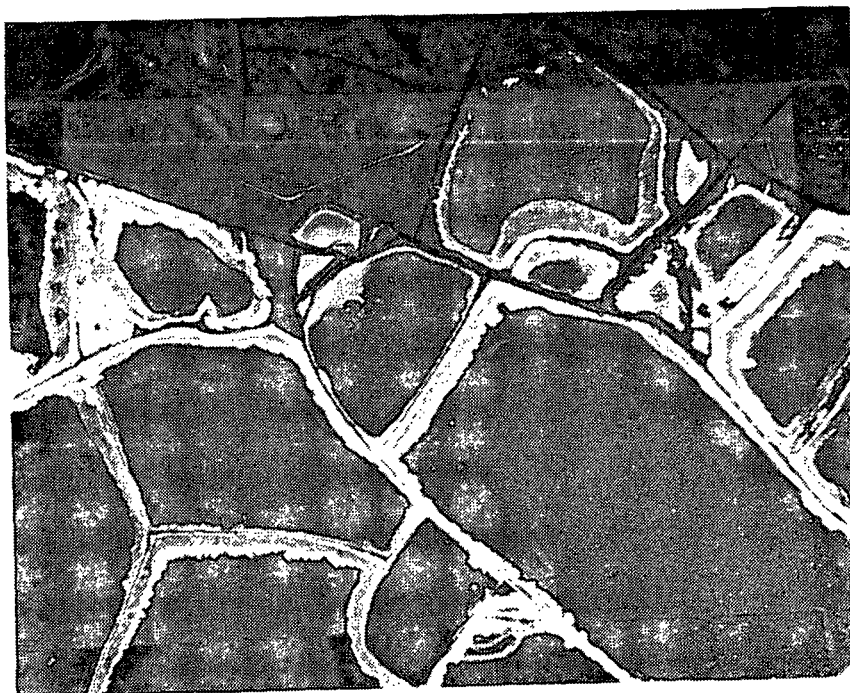
Figure 32. In this unwashed S&G coated specimen from the precipitator, salt-cake can be seen to penetrate the cracks, likely resulting in attack of the underlying metal substrate. (6X)

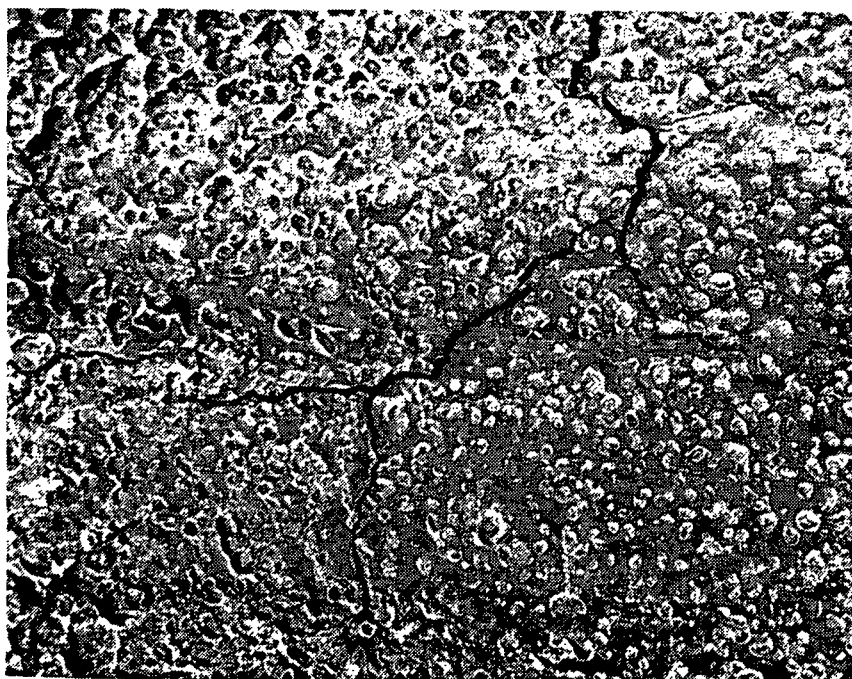
Figure 34. The Plasite 5306 coating suffered attack at the coating surface and experienced extensive, deep cracking in an exposure in the precipitator on panel No. 9. (6X)

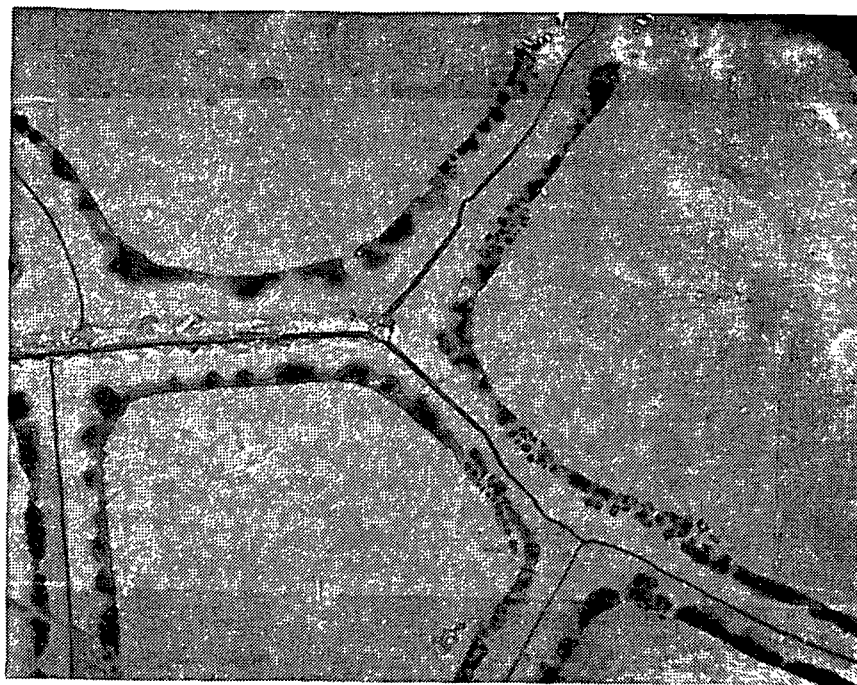
Figure 35. Cracks were observed to initiate from the area of intentional surface damage on a specimen coated with Plasite 9570. (10X)

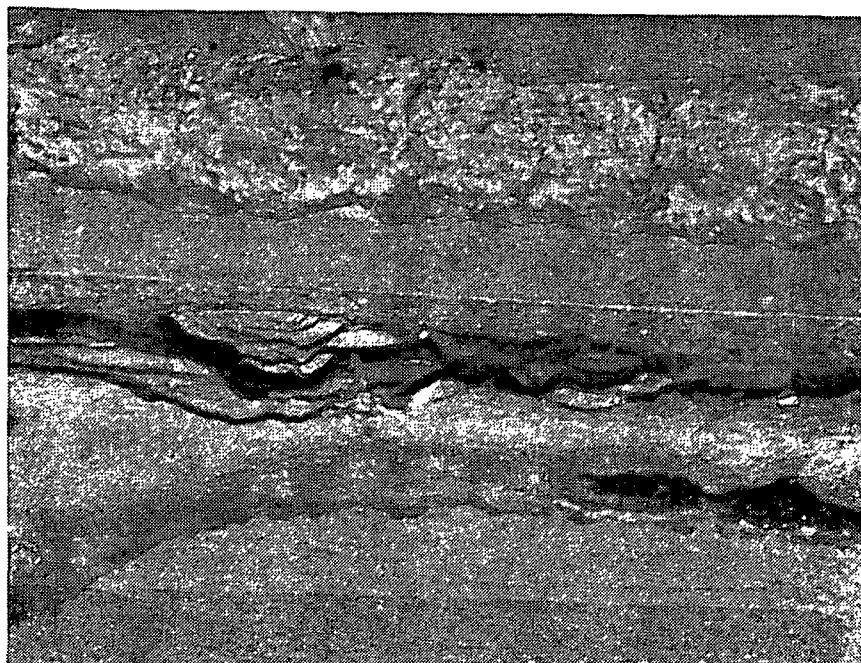
Figure 36. Cracking and disbondment of the coating was found laterally along the simulated damage zone of a Plasite 9570 coated specimen. (50X)

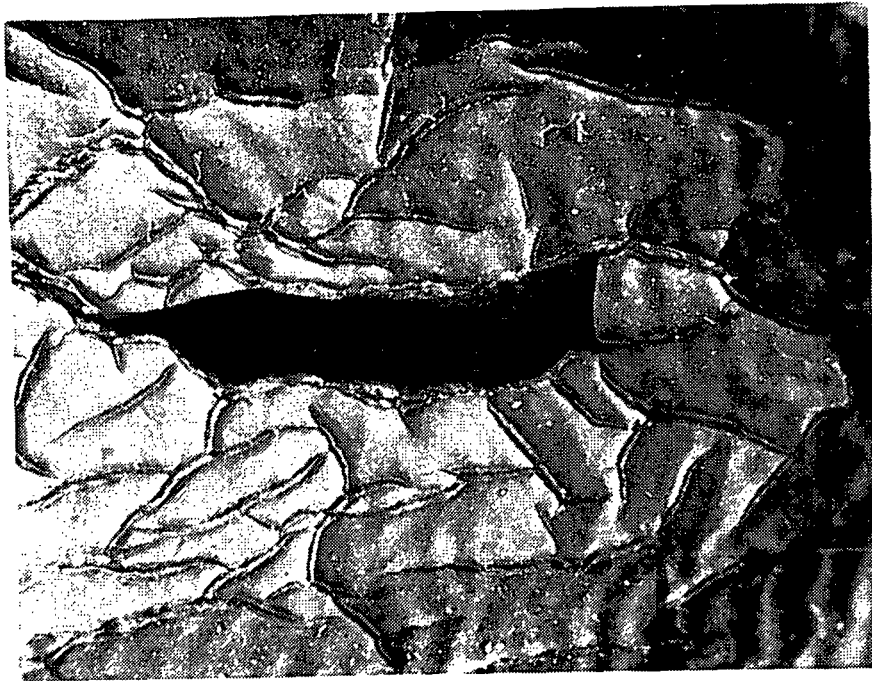
Figure 37. As the temperature limits of the Plasite 9500 coating were approached, the coating swelled, blistered, and cracked. (6X)

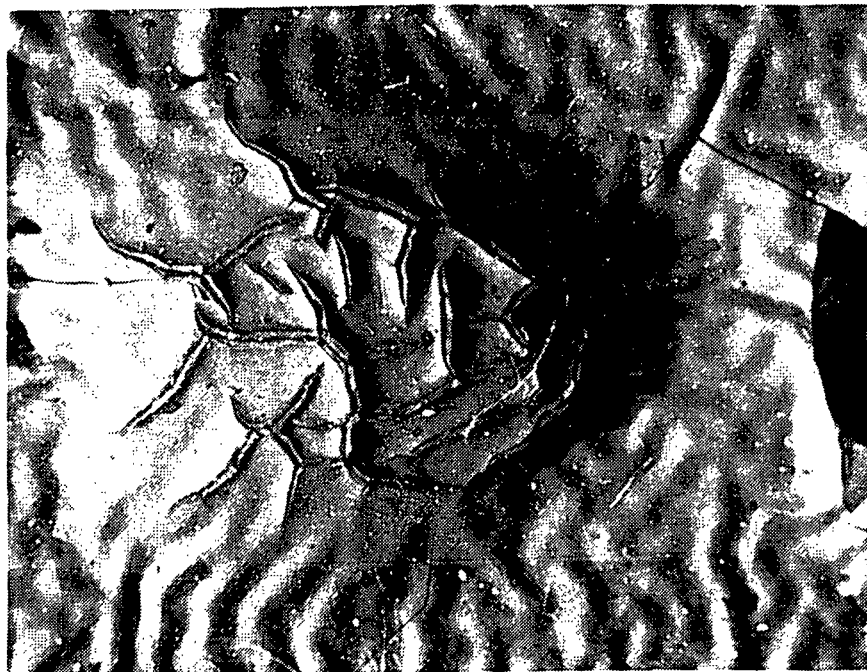
Figure 38. Failure of the coating was the result of coating perforation at the blistered areas shown in Figure 13. (6X)

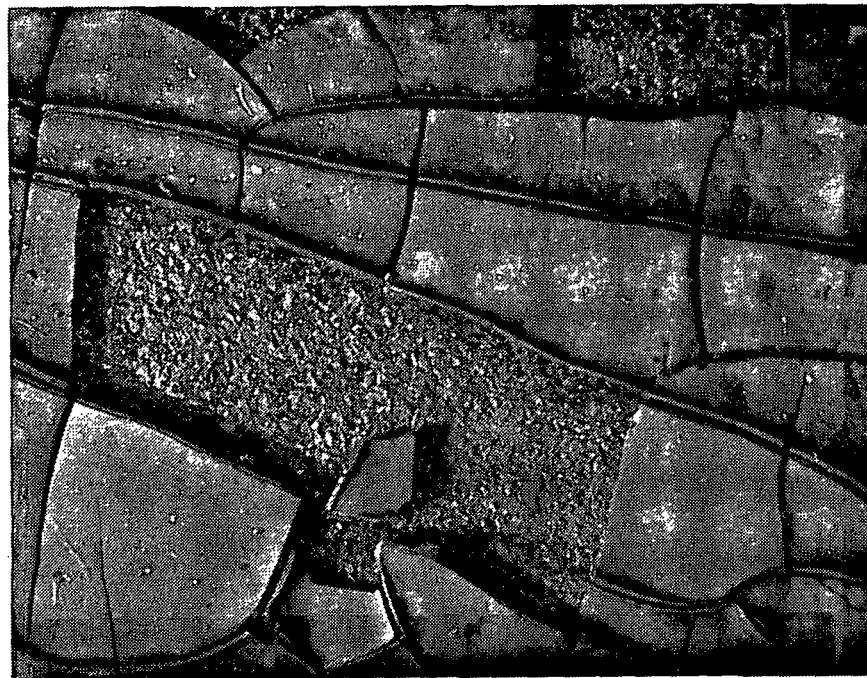
Figure 39. A specimen coated with Plasite 9570 failed due to cracking and flaking of the coating during a temperature resistance test. (6X)

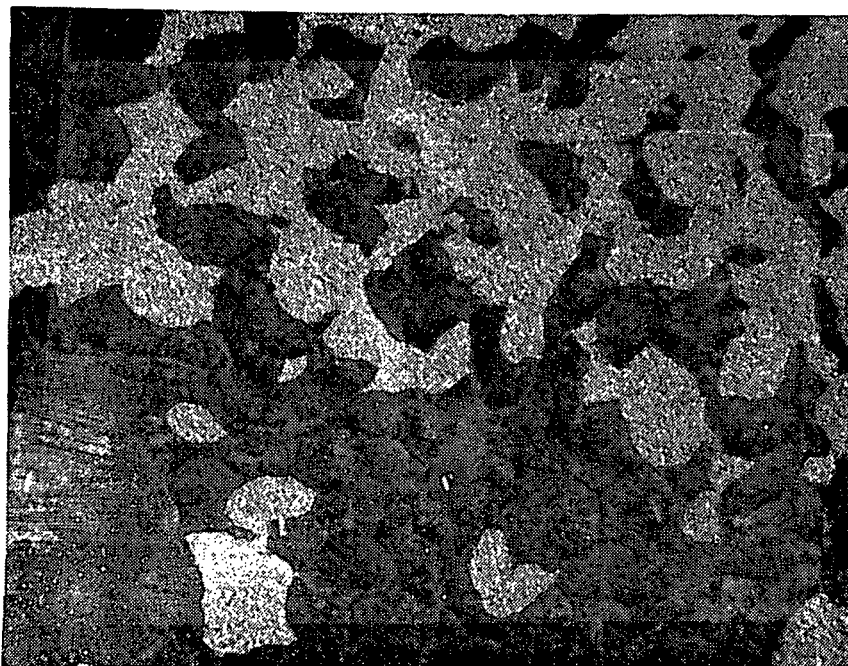
Figure 40. The Seal and Glaze 500 coating system cracked and peeled, but not until about 450°F. (6X)

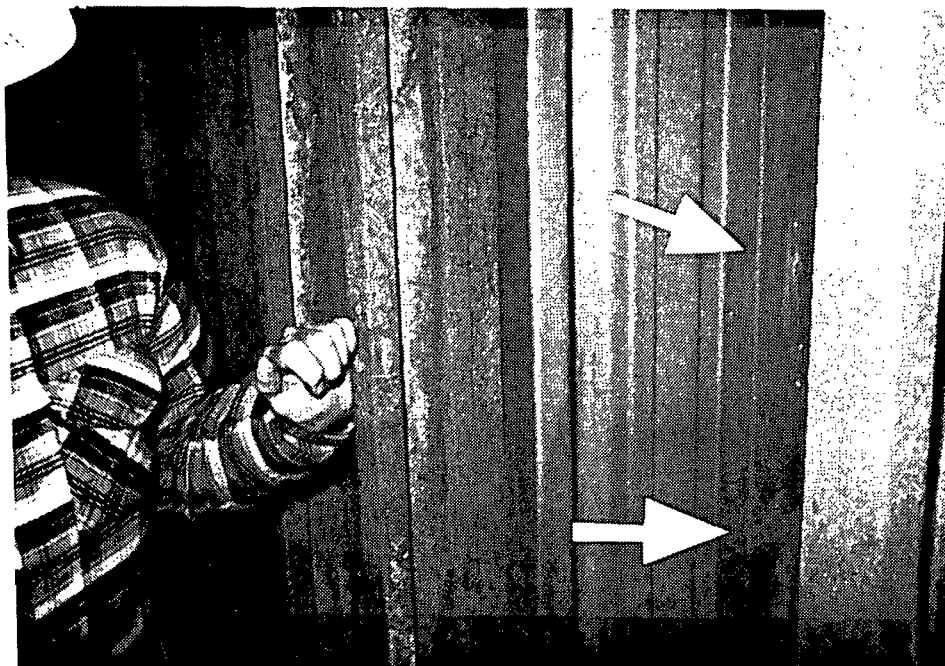
Figure 41. Corrosion of the carbon steel collector plate material at localized sites where holidays and pinholes existed in the Plasite 4140 coating system.

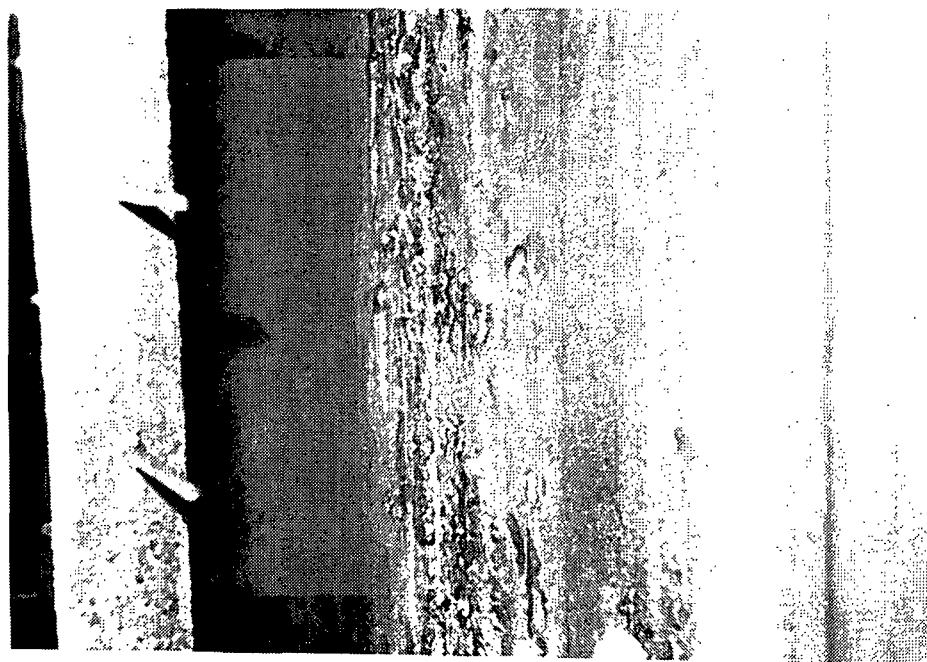
Figure 42. Deposition of corrosion products on the surface of a plate coated with the 1505C system.

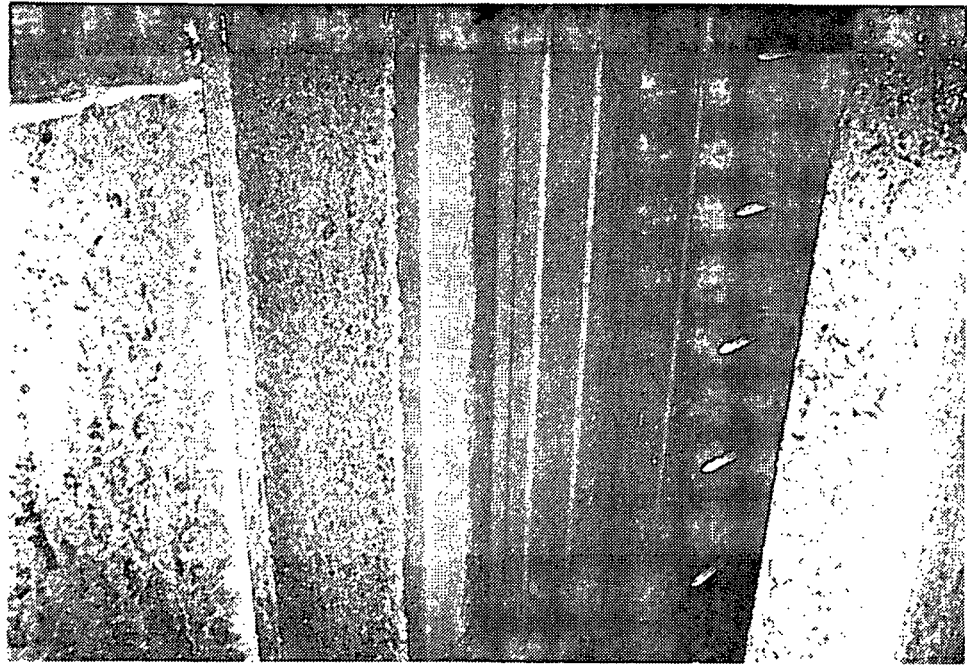
Figure 43. A vertical band of holidays and pinholes in a 4140 coated plate along an edge surface.

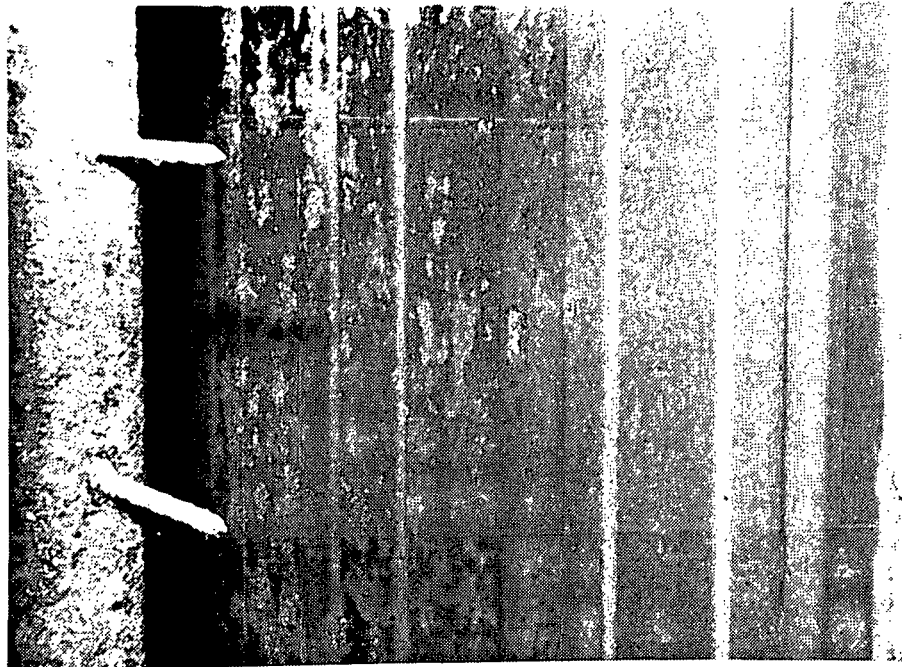
Figure 44. Randomly distributed holidays were often observed near the center of plates (1505C) coated plate shown).

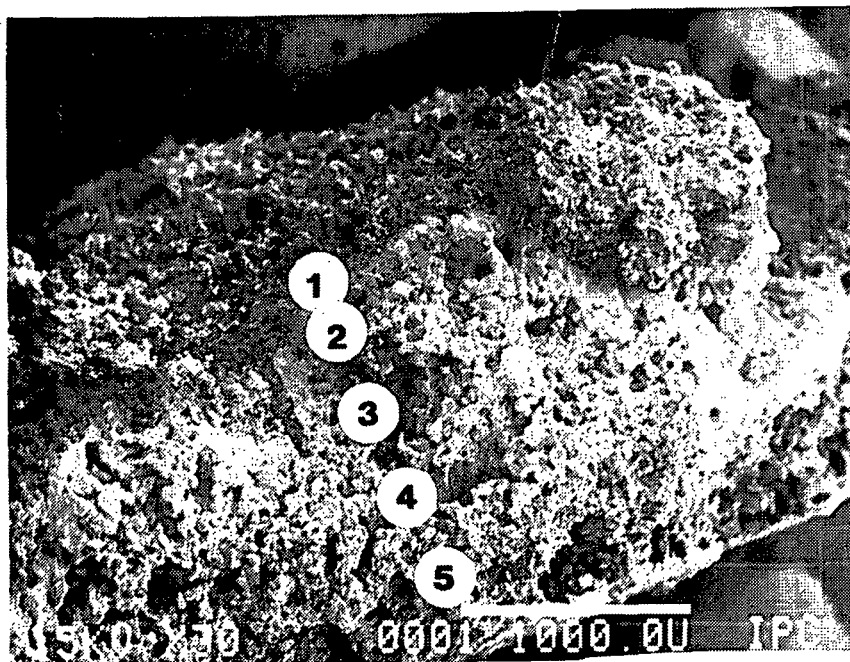
Figure 50. An SEM photomicrograph showing a layer of saltcake and corrosion products removed from an active corrosion site in an electrostatic precipitator. Multi-layered corrosion products (layers 1 and 2) formed beneath saltcake deposits (layers 3-5). (30X)
